HISTORIC PRESERVATION FUND

Final Report

Project Name: Fenestration: North Pacific Hall, Sheldon Jackson Campus

HPF Grant #12563

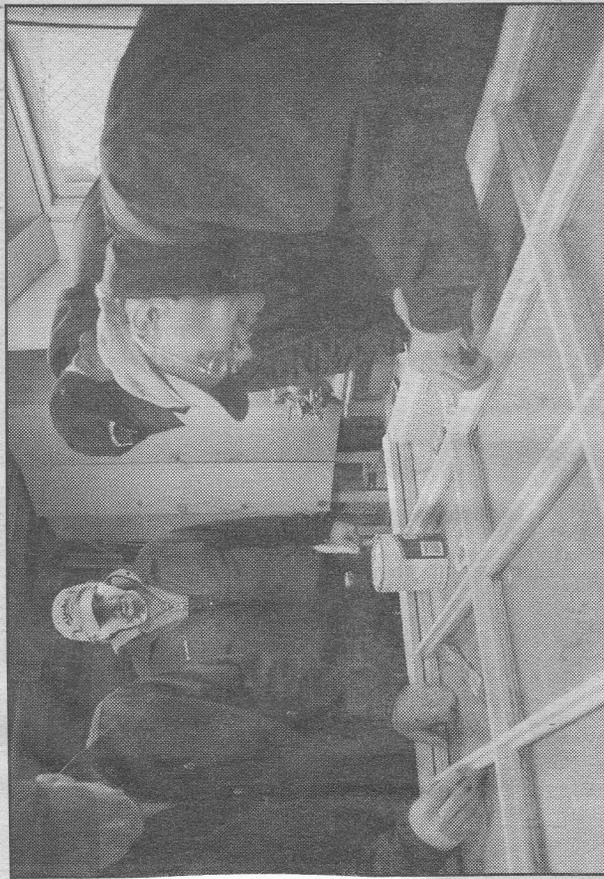
OLD WINDOW WORKSHOP – Restoration carpenter Steve Homer, from Hamilton Mass., right, demonstrates window glazing techniques on one of the 100-year-old windows on the SJ Campus Sunday. The two-hour workshop on making old windows weather tight and more energy efficient was hosted by the Sitka Fine Arts Camp. Local carpenter Eric Dow, who also taught at the workshop, demonstrated how interior storm windows cut down on heat loss and noise and don't affect the appearance of historic buildings. The workshop was made possible by a Certified Local Government grant. (Sentinel Photo)

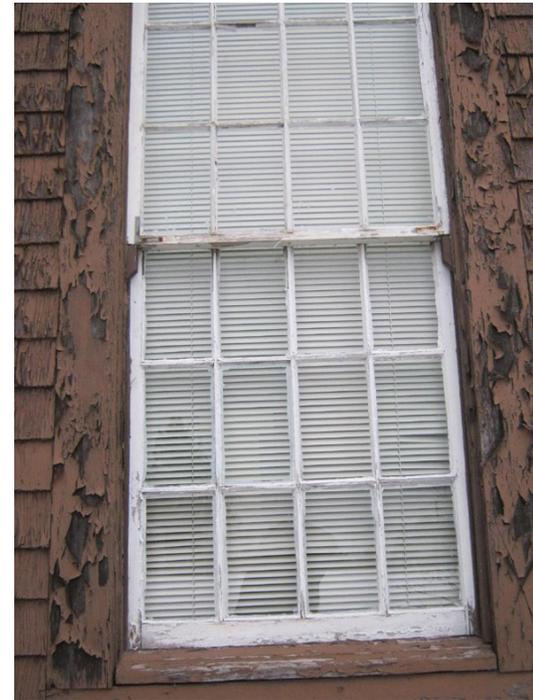
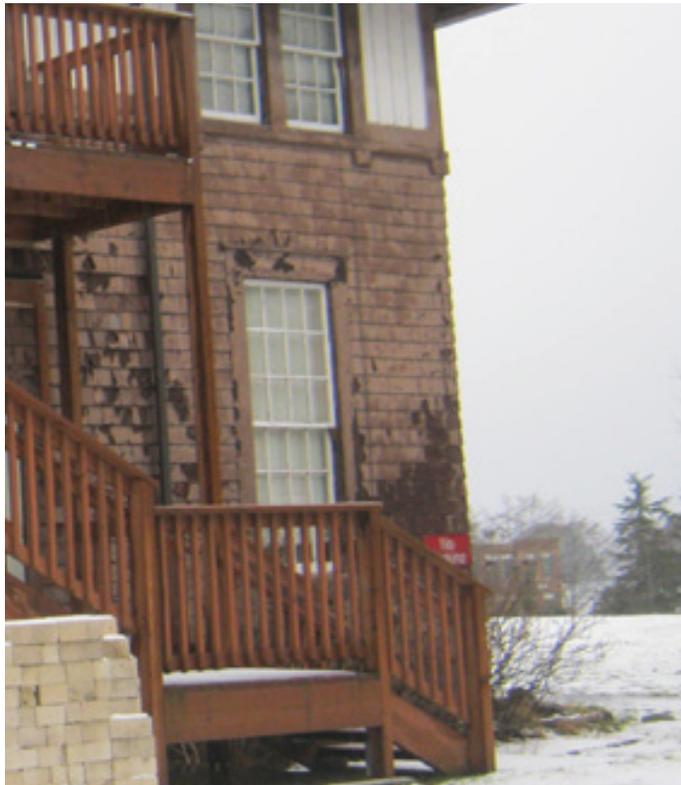
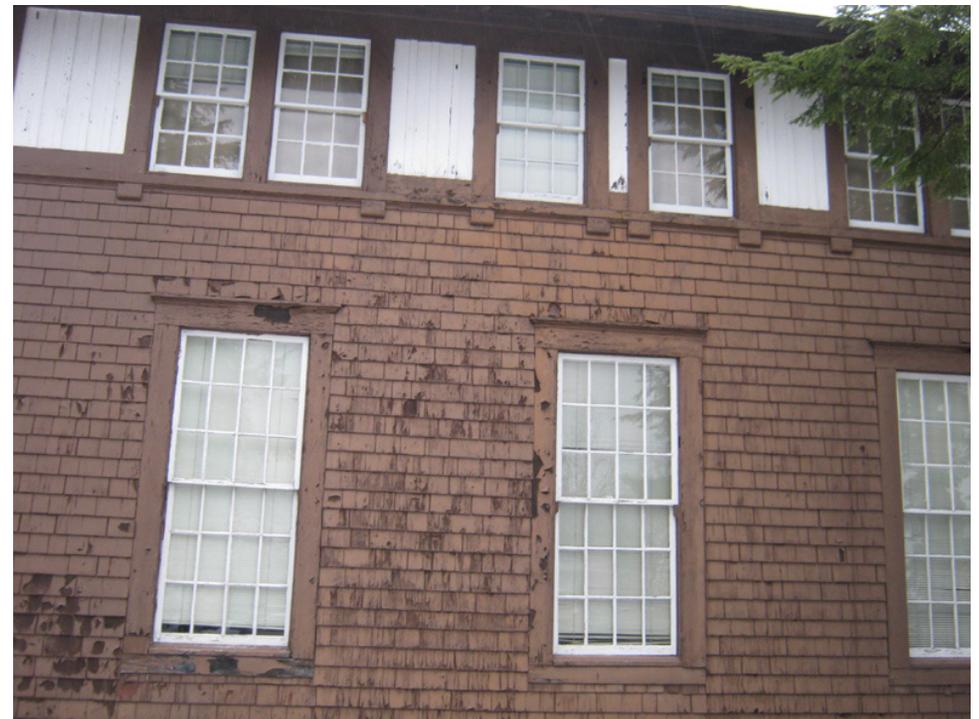
Inspecting all the windows

All of the windows were assessed for condition, inside and outside, and documented on a spreadsheet, noting broken panes, missing or broken sash locks, sash lifts, sash cord and other issues.

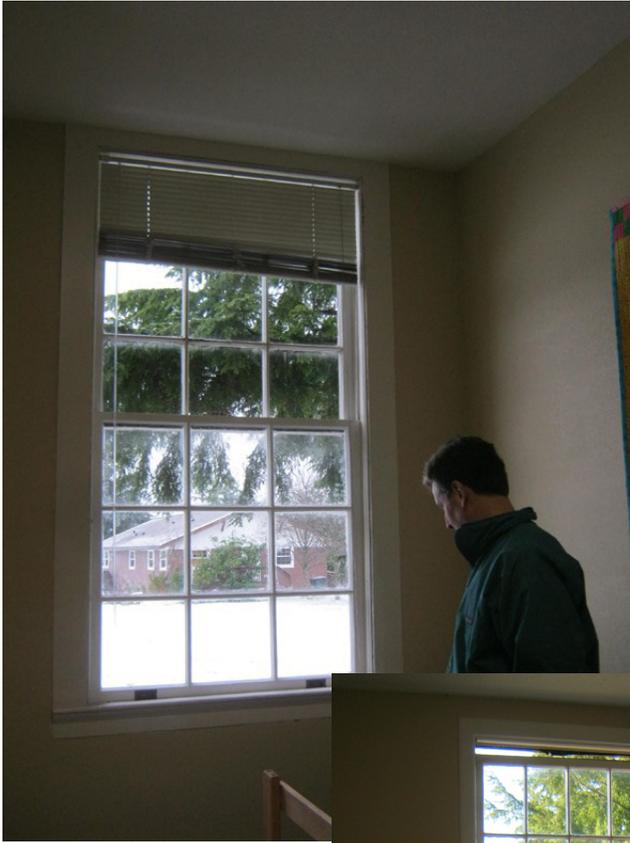
Taking out one of the windows, the lower rail on the upper sash was a bit loose

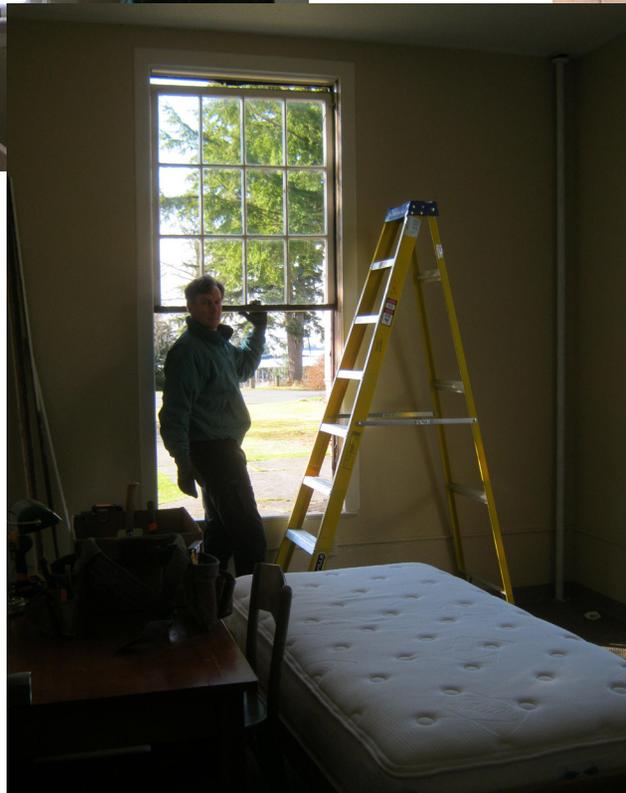
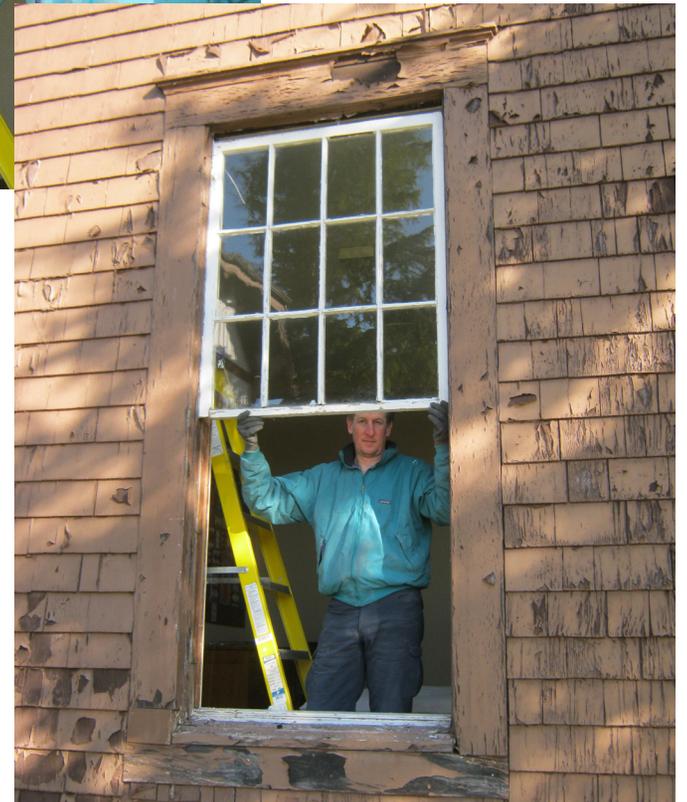
Detail of a window sash before repair, with typical past repairs and failing glazing compound

The sash we repaired were steamed and the glass and paint removed. Most had rot on the bottom rail, and some had part of the profile missing on some of the muntins, so this damage was repaired using liquid and putty epoxy.

Next they were primed with oil-base primer, then when that dried, glass was replaced, using Dual-Glaze brand putty. When that skinned, windows were lightly sanded and painted with self-priming exterior paint, and re-installed, with new hardware, trim repairs, sash cord etc. as needed.
